**SERVICE BULLETIN: 2015-0001****Issued 23 Feb 2015**

**Subject: Intruder Main Parachute Bottom Surface Stitch Failure****Affected Products:**

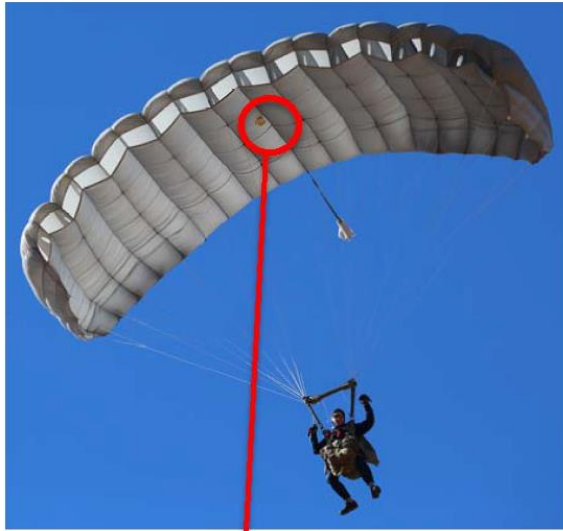
Damage Location

Using the Intruder 300 or Intruder 360 parachute in a freefall mode has resulted in reports of bottom surface damage. The damage consisted of broken stitches located at the bottom surface seam joining the center unloaded rib to the bottom surface panels. The stitches broke at the junction between the rib reinforcement tape located directly below the pilot chute attachment point and the bottom surface reinforcement tapes (See images below).

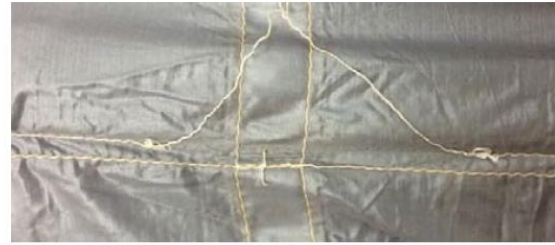
Broken stitches, bottom surface view

This joint represents the weakest point in the load path. Therefore depending on the jumper weight and speed at parachute activation, the snatch force generated by the pilot chute can be sufficient to break the reinforcement stitch. Once the stitch rows are broken the load path is transferred onto the left and right panels of the top surface and to the reinforcement tapes on the loaded ribs. As a result, the stitch failure does not propagate any further.

All canopies in the field should be inspected at the subject area described above and reinforced or repaired based on the following conditions:

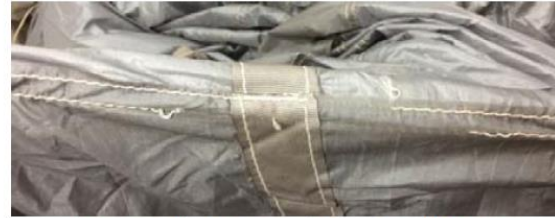
Junction between rib tape and bottom surface tape, view from inside the cell

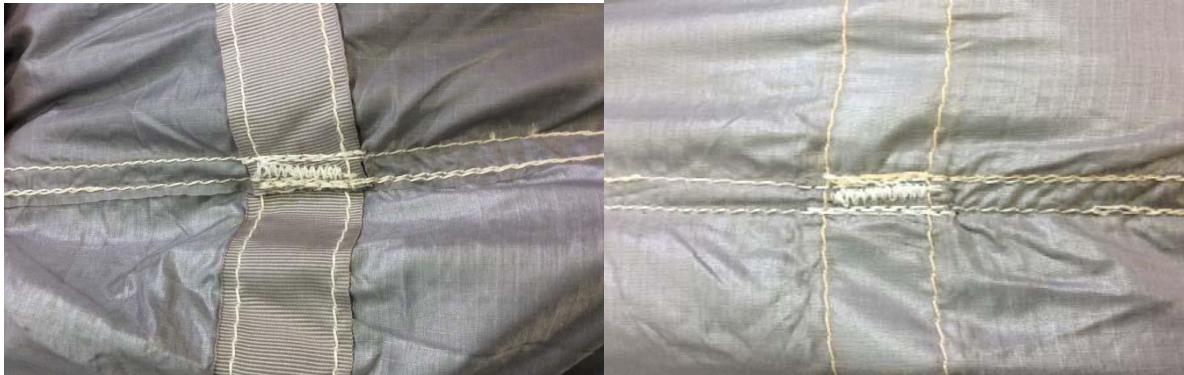
View from inside the cell

Bottom surface view

If no damage or stitch failure is found, the junction must be reinforced by placing a bartack at the junction between the existing stitch rows (See pictures below). Use a 42 stitch bartack, 1/8" wide X 3/4" long, sewn with size E nylon thread.

The addition of the bartack increases the joint strength to approximately 300 lb. This solution has been fully tested for maximum operating speed and weight.
